National Dam Inspection Program.

Lower Kittanning Dam (NDI-529),
Susquehanna River Basin, Burgoon
Run, Blair County, Pennsylvania.
Phase I Inspection Report.

PHASE I REPORT
NATIONAL DAM INSPECTION PROGRAM

PHASE I REPORT
NATIONAL DAM INSPECTION PROGRAM
LOWER KITTANNING DAM
NDI I.D. NO. 529
DER I.D. NO. 7-14

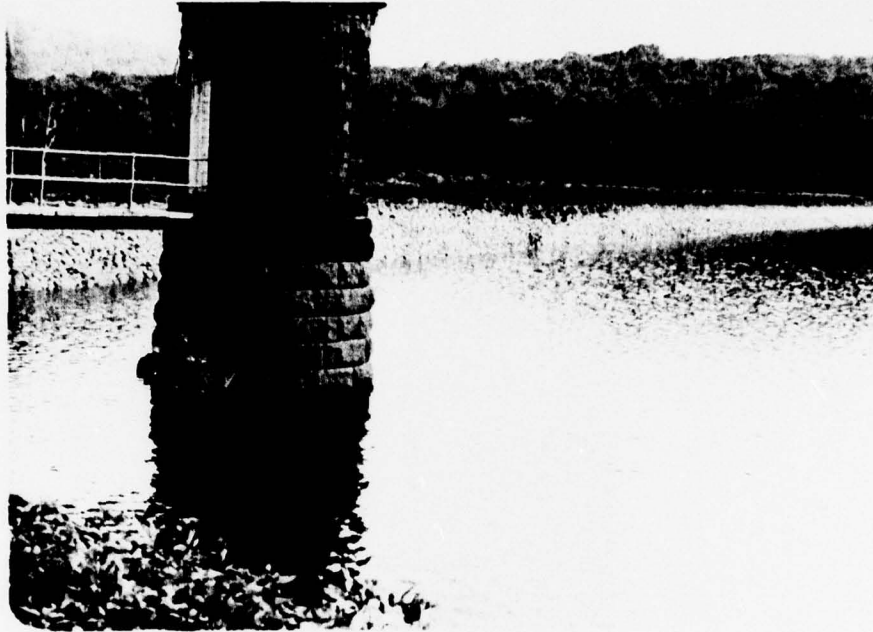
Upstream Face

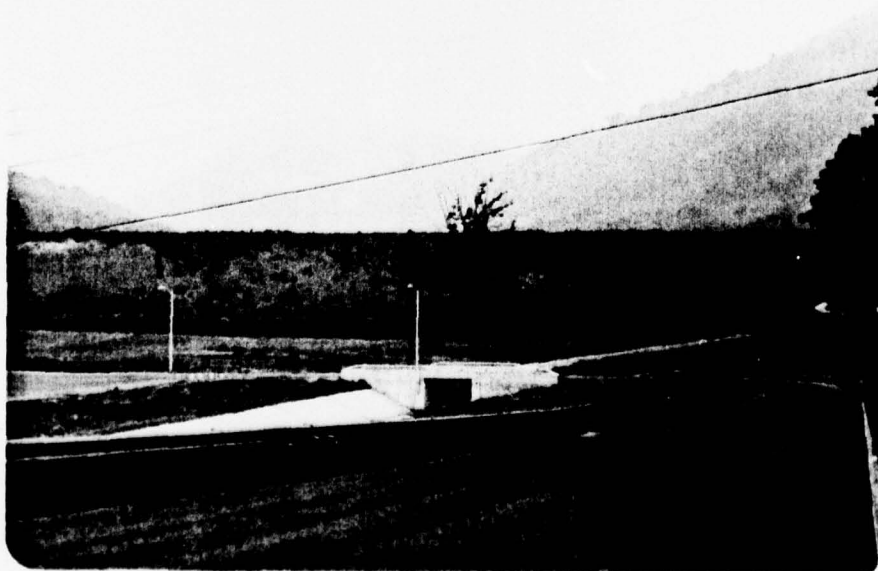
Downstream Face

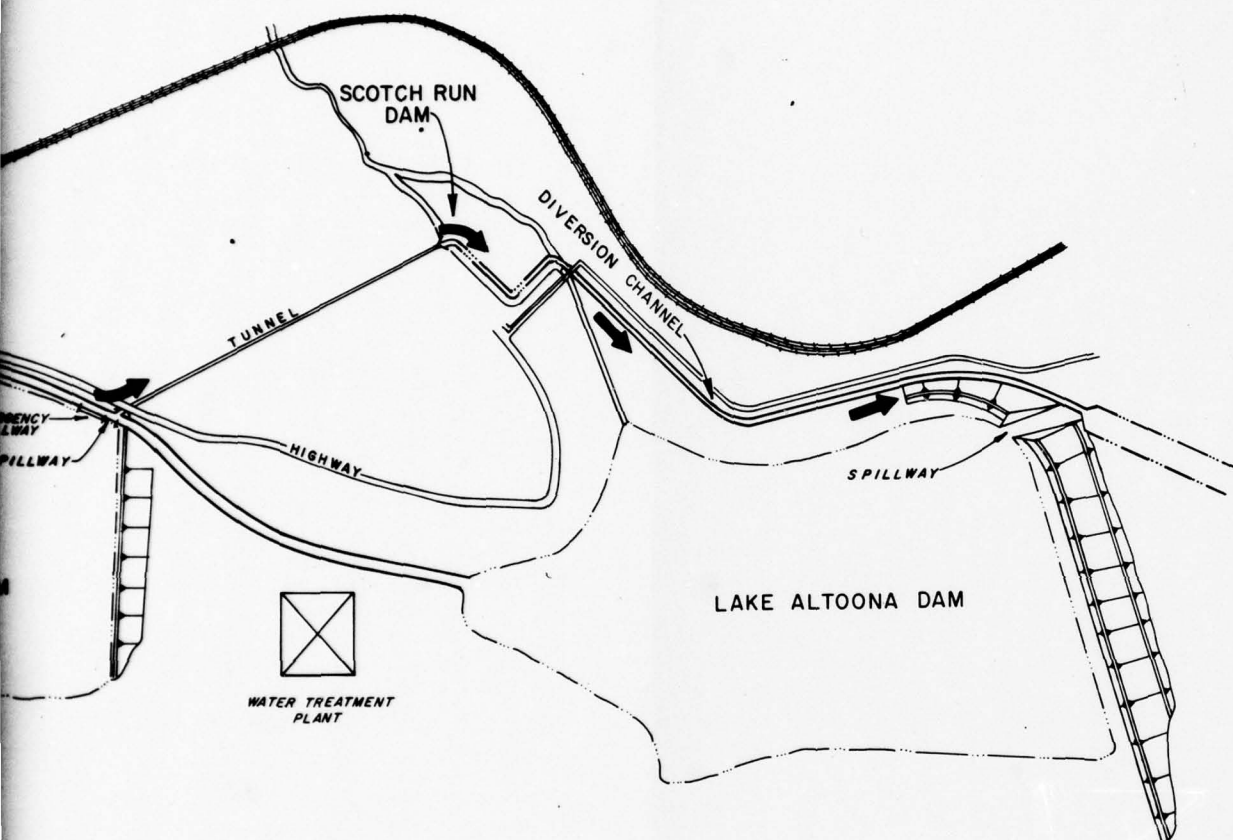
PLATE 2
LOWER DAM
DIVERSION CHANNEL PLAN
D'APPOLONIA

The normal runoff from the Burgoon Run watershed is diverted by a channel and bypasses the reservoir (Plate 2). The inflow into the reservoir would be discharged through the primary and emergency spillways and flow into the Lake Altoona Dam reservoir, which is located about 3000 feet downstream.

The concrete in the diversion channel was found to be deteriorated due to action of acid mine drainage. However, the condition is not considered to be to an extent that would affect the structural performance of the concrete.

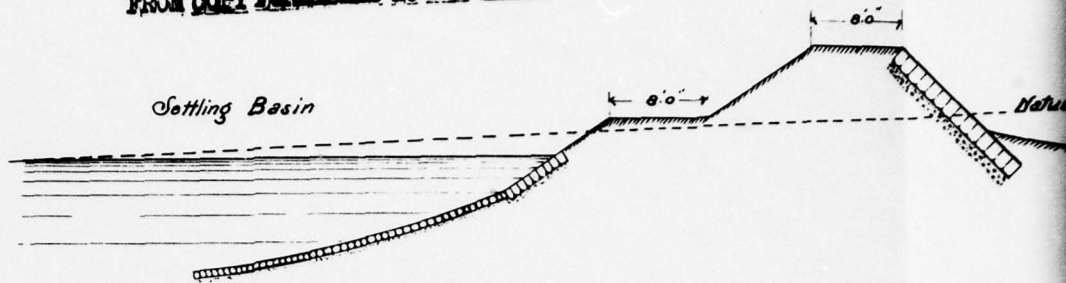
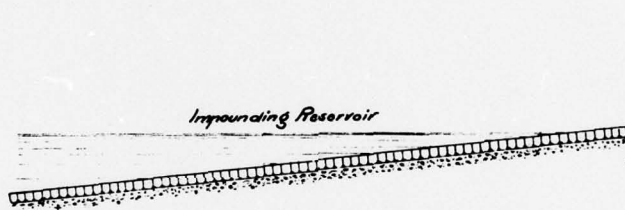
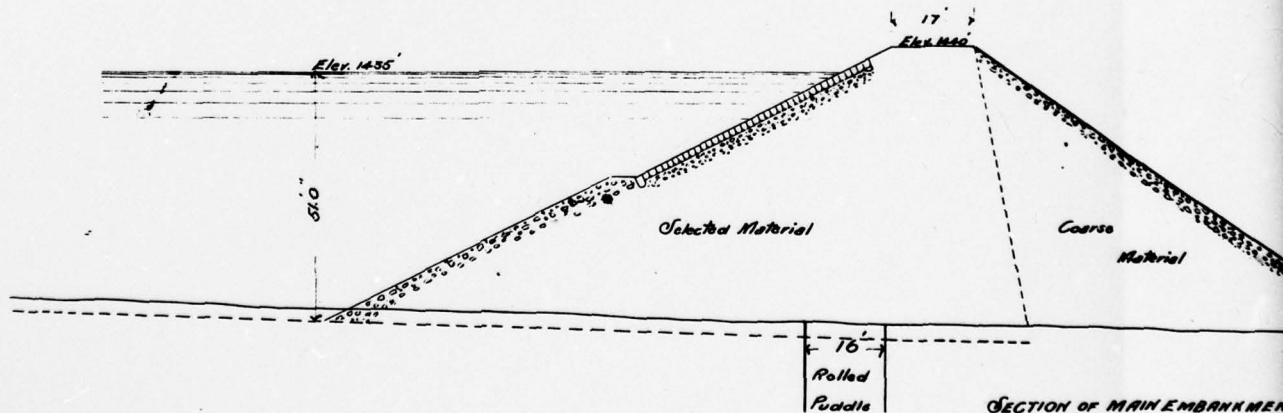
- a. As designed, the dam is a zoned embankment consisting of "select material" in the upstream zone and a "coarse material" in the downstream zone (Plate 3). An approximately 20-foot-deep, 16-foot-wide "puddle clay" cutoff trench extends along the entire length of the dam (Plates 3 and 4).
- b. The embankment was designed to have a two to one (horizontal to vertical) slope on the upstream face and 1.5 to 1 slope on the downstream face (Plate 4). Both the downstream and the upstream faces were protected by riprap.
- c. No reference to a subsurface investigation was found. A design drawing (Plate 4) indicates that the cutoff trench was extended to the top of rock which is classified as "red and gray" shale.

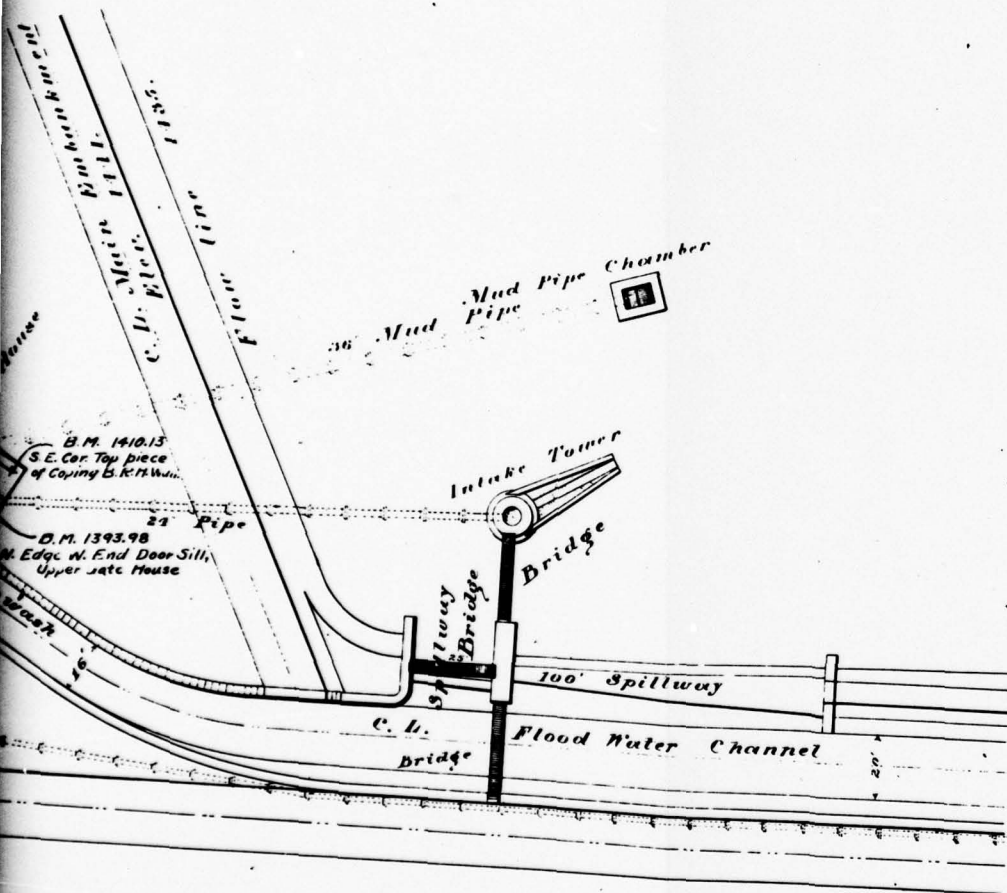
PLATE 6

The outlet pipe through the embankment is controlled by downstream valves. Therefore, the pipe is always under pressure. It is recommended that the owner evaluate the structural integrity of the pipe through the embankment and develop means for upstream flow control on the pipe.

(3) Appurtenant Structures. Very limited information is available on the design of the outlet works. Plate 6 shows the arrangement of the blow-off and the supply line through the embankment. No information is available on the structural details of the pipes through the embankment, such as whether concrete encasement was used.
